Technical Specifications

SILVERWING FLOORMAP

High-Speed Tank Bottom Inspection System Featuring Top and Bottom Plate Corrosion Views.

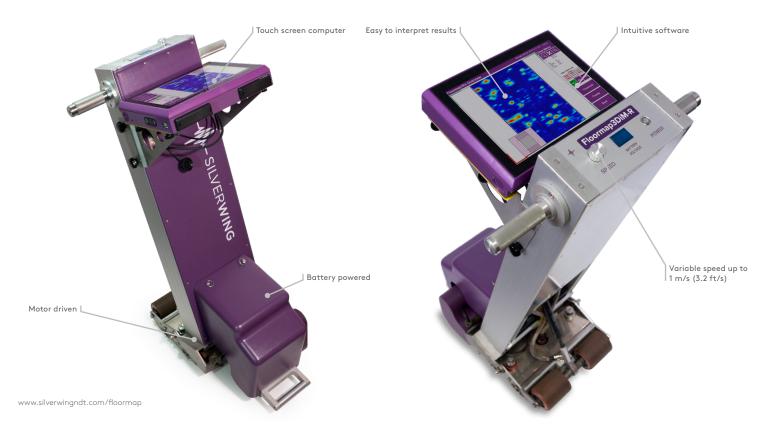
SIMS inspection mapping software automatically creates a corrosion map of the inspected tank bottom. Multiple views, analysis tools and automated reporting simplifies the post inspection process.

Silverwing Floormap collects crucial inspection data at speeds up to 1 m/s (3.2 ft/s), this is made possible by the high-powered rugged touch-screen computer and advanced software processing. Silverwing Floormap produces a detailed plan view of the inspection area, operators can immediately view the scanned track and switch between multiple views, all designed to gain a better understanding of the tank bottom without the interpretation of complex signals as seen with other NDT technologies.

MFL view: details all defects in the RAW unfiltered representation.

STARS view: depicts only top side defects, even through coatings up to 6 mm (1/4'').

MFLi high intensity view: aids in the classification of corrosion.
